## The Wall of the Western sector of the Alcazaba

### Mérida

CLIENT	<b>Culture Office. Government of Extremadura</b>
PROJECT DATE	<b>2007</b>
LOCATION	<b>Mérida, Spain</b>
FIELD OF ACTION	<b>Research &amp; Restoration projects</b>

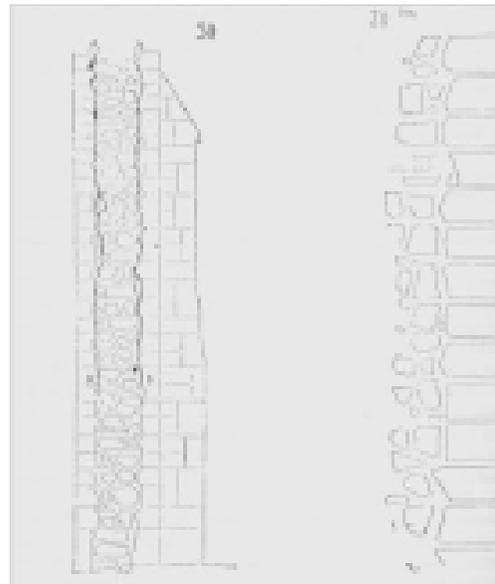
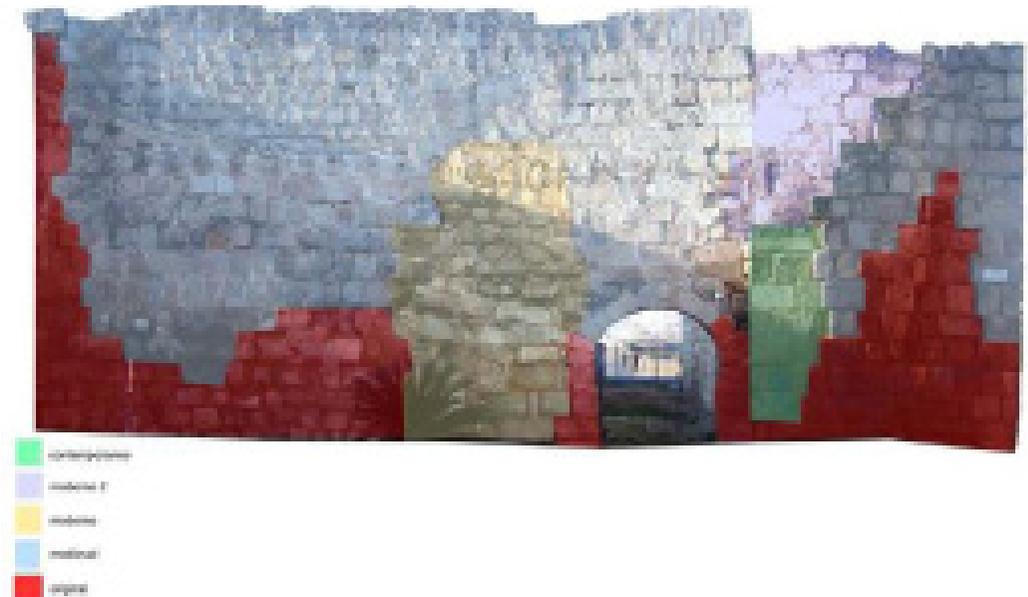
The main reason of the detected damage is the loss of the case-hardening stuffed inside the walls and the bad grain size measurement.

The stuffing is out of condition principally due to the suffered washing through the run-off water flowing from the crown to the base of the walls, where it comes out sweeping a part of the filling material.

It has been also detected strength damage (fissures, separation of ashlars, convexity of the walls, etc.) which mean an incorrect tensional operation, because of a poor durability or a wrong maintenance of the structure, rather than a bearing failure of the wall.
