Restoration of Cardenal Cisneros Square, A-6 Motorway Madrid

CLIENT	City Council of Madrid
PROJECT DATE	2014
LOCATION	Madrid, Spain
FIELD OF ACTION	Construction project and Technical assistance during construction

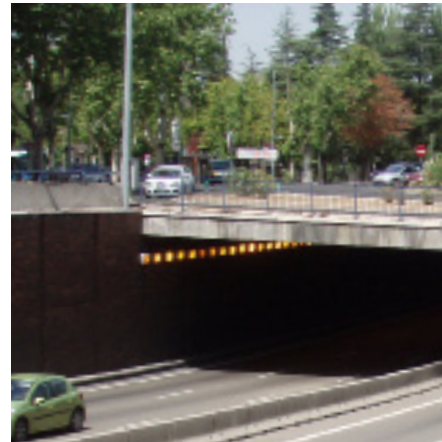
Before the works

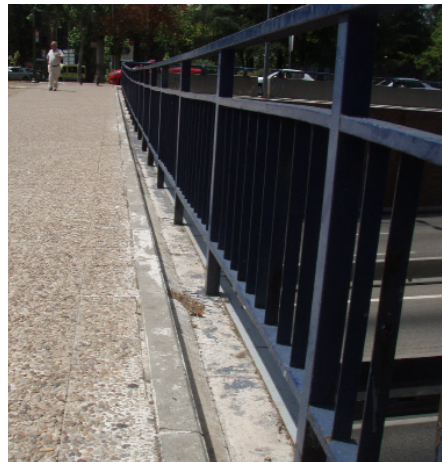
Before the works

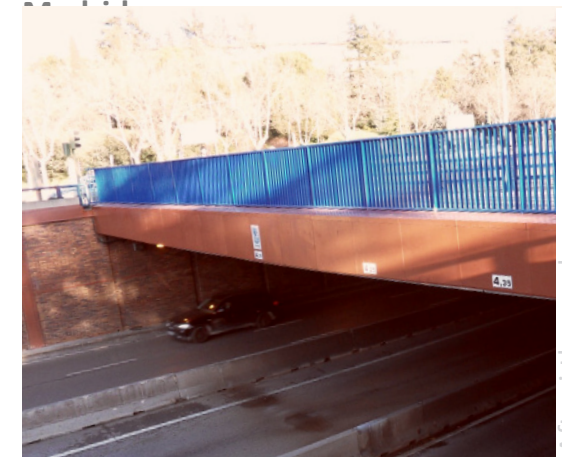
After the works

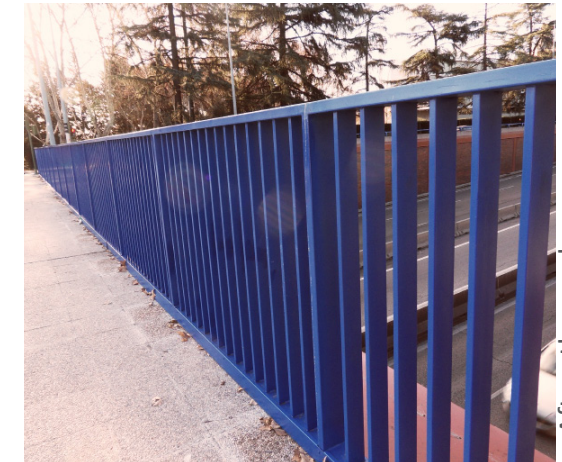
After the works

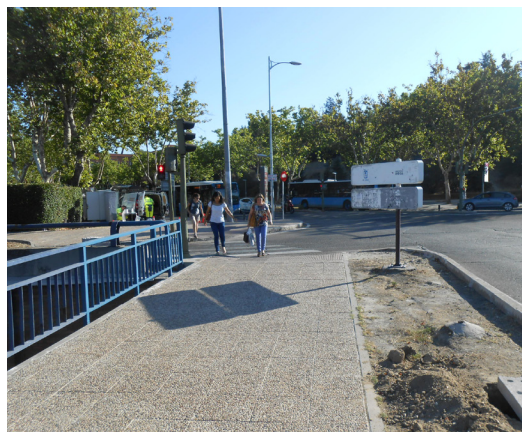
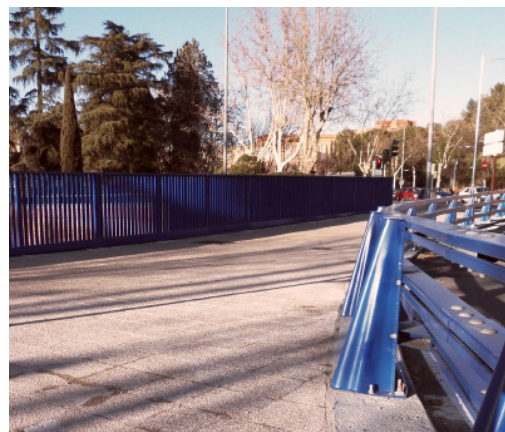
Before and after the works: traffic barrier

As a result of the detected damages, a materials study and structural assessment were carried out, in order to determine the required actions to restore an adequate structural and functional safety level of the work. In addition, between the paved road and the sidewalk, a steel parapet for the pedestrian protection was built.

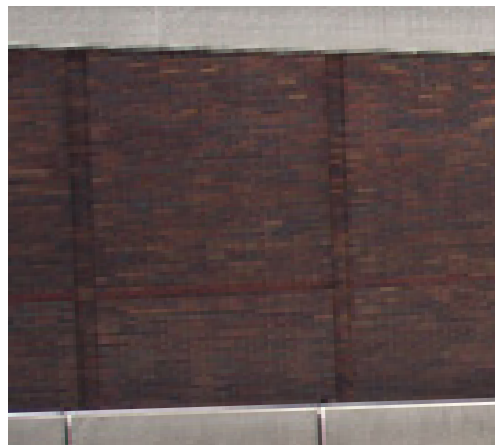
Before the works

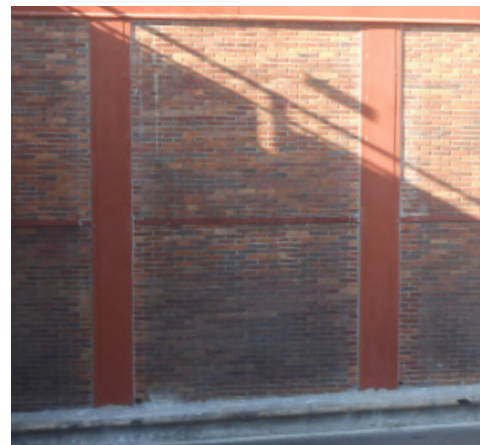
After i the works

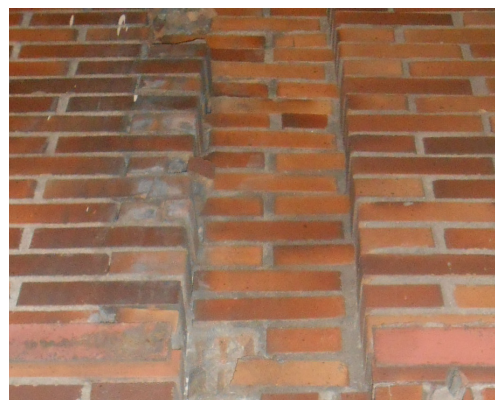
Before the works

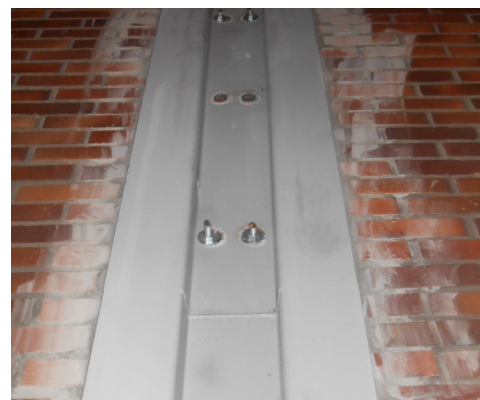
After the works
