INSTRUCTION PROJECT AND TECHNICAL ASSISTANCE

A-6 Motorway Bridge over Manzanares River

Madrid

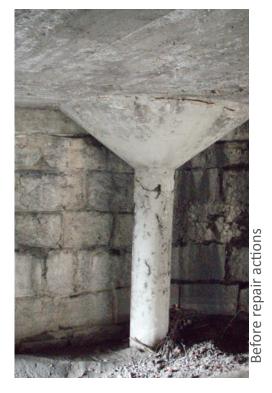
On the deck: there were losses of the concrete cover due to corrosion, generating flakes with exposed rebar in almost all the spans; moisture stains and leaks; efflorescence and loss of the slab protective treatment, due to bad waterproofing and the climatic action.

In the piers: there were also flakes with exposed rebar in the capitals due to corrosion (almost all the piers of the original bridge); as well as several cracks in shafts and capitals.

The damaged areas of the structure were rehabilitated with lime mortar. Due to the general loss of the concrete cover, the advanced progress of the carbonation process and the high porosity of the concrete, the walls had to be waterproofed and protected by applying flexible two-component coating with a cementitious base of a minimum dry thickness of 2mm. That coating works as an anticarbonation barrier and is resistant to the chlorides penetration.

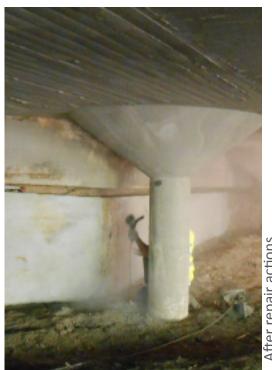
In the abutments and wing-walls: moisture stains, leaks and loss of protective treatment due to bad waterproofing of the expansion-joint corresponding to the front bearing wall of the enlargement as well to the retaining wall of the original work; cracks on the masonry lining of the front bearing wall of the abutment 1 of the original work, on the left side of the abutment 2 on the front bearing wall and the front wall of the abutment 2 of the widenning; moisture stains and efflorescence because of a bad waterproofing of the expansion-joint.

In the handrail: corrosion in some steel elements and also broken due to impacts.

The project also includes the replacement of all the expansion-joints by a water collection Hypalon band. Also a water drip element was done placing an angular galvanized steel profile on both sides of the deck.

Finally, all the damaged rail sections were repaired and repainted.
