Padre Huidobro Avenue Bridge, Highway A-6 Madrid

CLIENT	Madrid City Council
PROJECT DATE	2014
LOCATION	Madrid, Spain
FIELD OF ACTION	Construction project and Technical assistance during construction

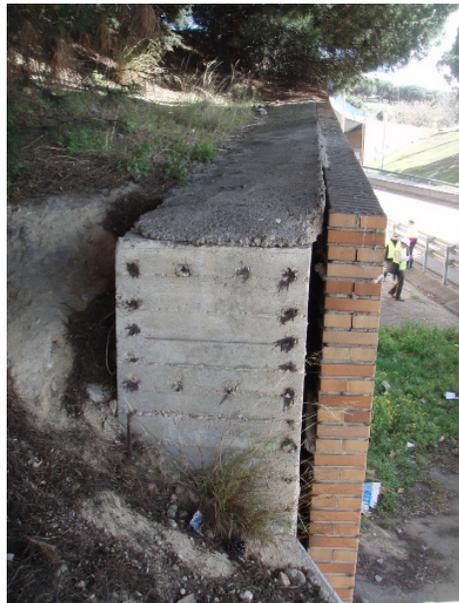
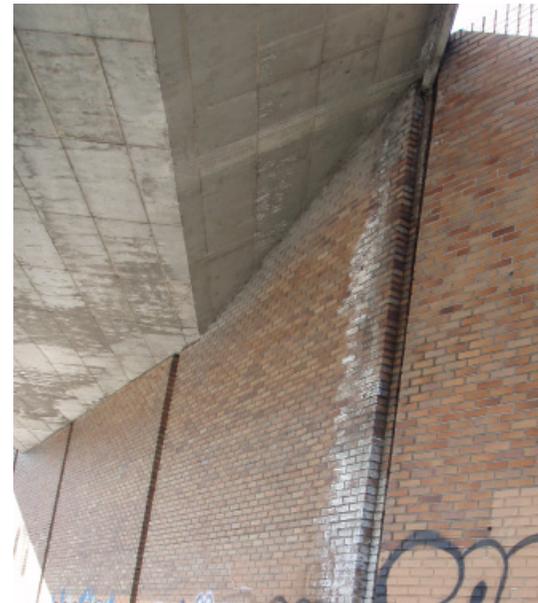
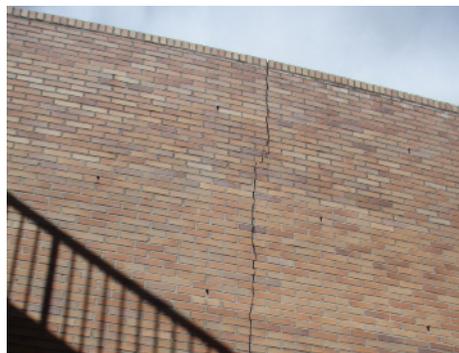
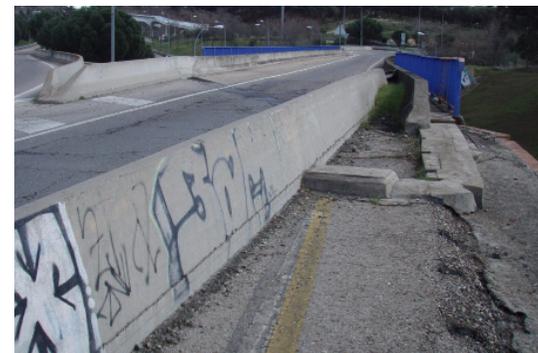
CONTORNO 1 MUROS LATERALES. ALZADO DESARROLLADO
Escala: 1:50
OBRAS: REPARACIÓN Y MANTENIMIENTO DE LA OBRA

The main damages of the structure were the moisture, leaks and efflorescence on both spans of the slab due to an inappropriate waterproofing; patina because of the corrosion of the slab reinforcement; and cracks of medium importance. In the pier, there are cracks on the top of the shaft lining, due to an excessive pressure between elements. In the brick of the abutments and wing-walls, lining were found both cracked and loose elements due to the excessive pressure, as well as moisture and leaks because of the bad waterproofing. On the platform the pavement had general damages.

For the regeneration and stabilization of the brick lining the structural walls of the abutments and for the wing-walls, several actions were defined and they are following described.

In order to repair the fissures or cracks and the vertical relative movements in relation with the concrete wall, first those cracks were injected with milk at low pressure.

Moreover an upper and continuous anchorage system from the masonry to the concrete one was built, through a cap of 50 cm (over a regularization mortar) that binds them, this cap was anchored to the concrete walls with vertical anchorages of $\varnothing 16$ each meter. This solution was combined with horizontal anchors with a diameter that decrease (from $\varnothing 500$ to $\varnothing 200$ mm) when the vertical distance from the coronation increase.
