Restoration of the arcade of Bojes Patios

Sevilla

CLIENT	CEDEX. Ministry of Culture
PROJECT DATE	2009/2010
LOCATION	San Fernando, Spain
FIELD OF ACTION	Research & Restoration projects

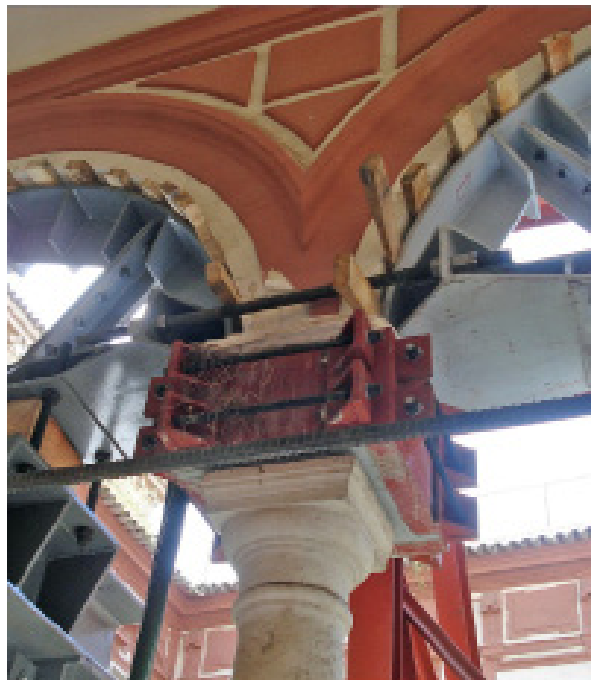
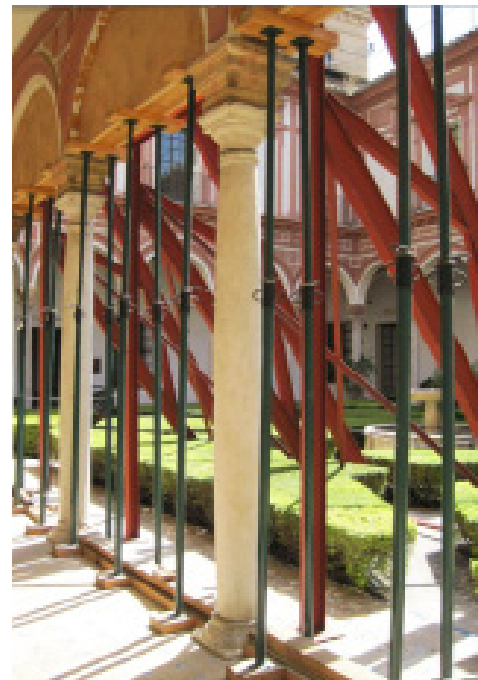
Many of these cymatium, are considerable damaged; specifically in six located on the north face undergo an intense weathering and one of the elements is fractured by two vertical planes.

The vertical load resting on each cymatium is about 200 kN, which suppose compression stresses of 2.2 N / mm^2 and pulling stresses of 0.27 N / mm^2 in the stone. These values are very moderate compared to the characteristics of the intact stone, but high of compared to the characteristics of the ostonera when it is strongly weathered.

CEDEX asked INES to do a diagnostic study and different proposals of action. As a result of this works, it was concluded the need to replace the 6 most affected cymatium; as well as an active shoring system and a replacement procedure were sized.

The Ministry of Culture required INES then the Construction Management of the Emergency Project awarded to the company Betazul. Its aim is to replace the current shoring with a new more effective one, in order to allow applying vertical forces, which unload the cymatium before its replacement.
