Restoration of Sancti Petri Castle

Cádiz

CLIENT	Spanish Environment Ministry
PROJECT DATE	2007-2010
LOCATION	Cádiz, Spain
FIELD OF ACTION	Construction Project and Technical assistance during construction

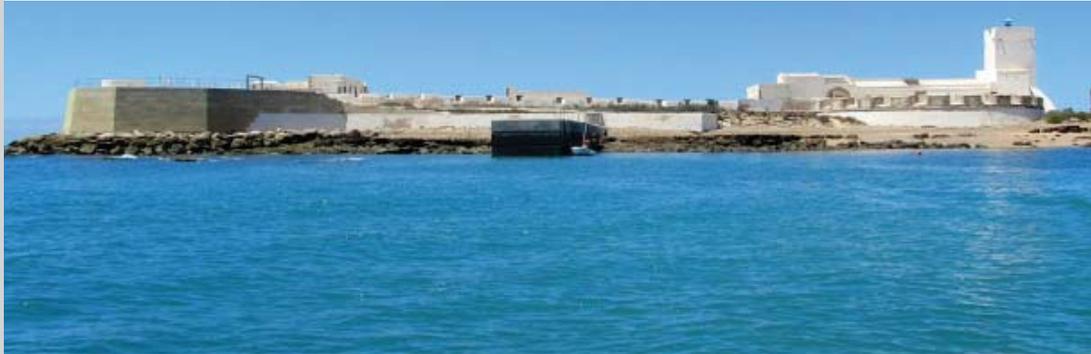
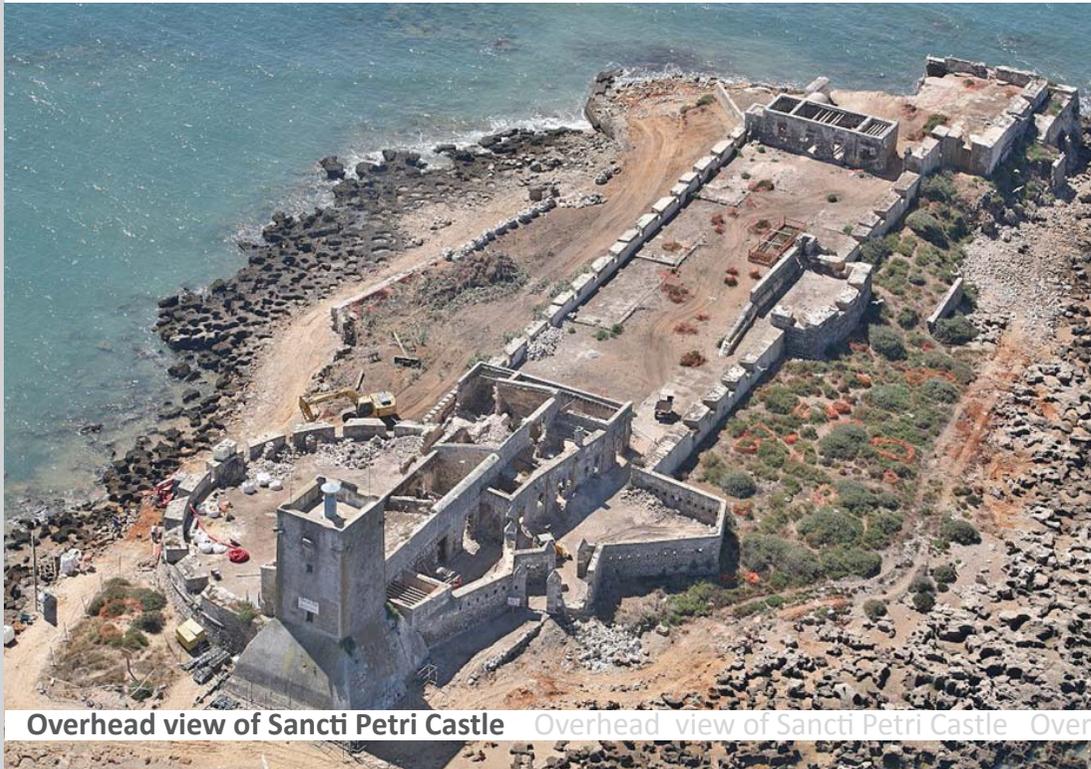
Overhead view of Sancti Petri Castle Overhead view of Sancti Petri Castle Over-
