Restoration of the arcade of Bojes Patios

Sevilla

CLIENT	CEDEX. Ministry of Culture
PROJECT DATE	2009/2010
LOCATION	San Fernando, Spain
FIELD OF ACTION	Research & Restoration projects

Bojes Patio is one of the cloisters of the Museum of Fine Arts in Seville, built in 1602, by Juan de Oviedo.

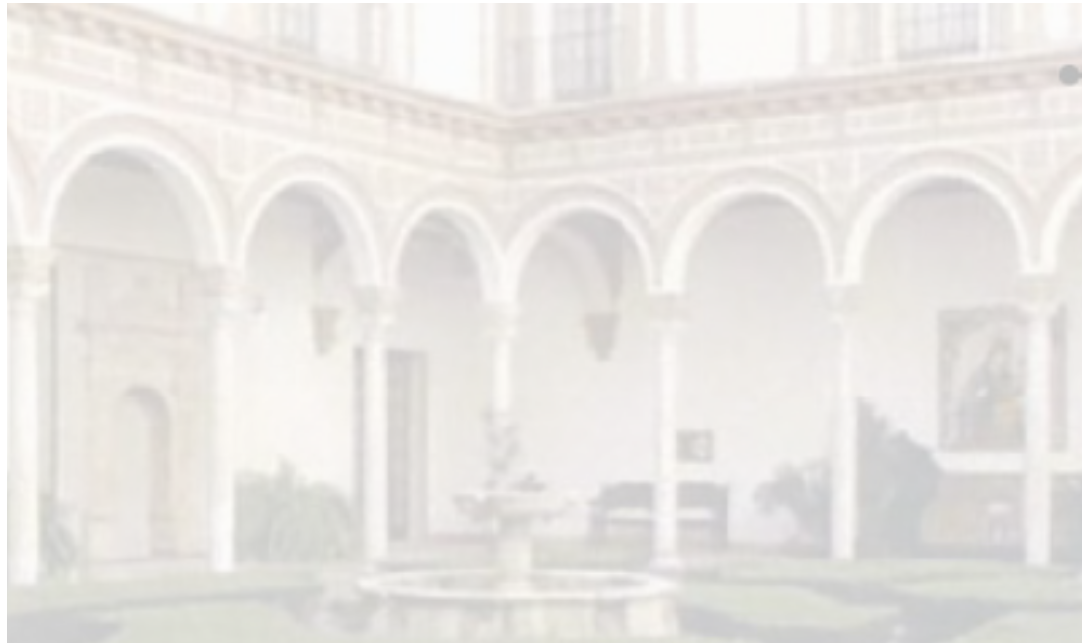
The cymatium (abacus standing on the capital) which are located over the 24 marble columns, are made of ostionera stone, material also founded in the Cathedral which involves lot of durable problems. Over the cymatium, arches of 2.85 m span are built, brick masonry spandrel walls of 0.32 m thick, higher wall of 0.55 m height, also made of brick and the roof and below cover plants. In the galleries, which are located just over the arches by twos, hang the works of the masters of Seville School of Painting.

Many of these cymatium, are considerable damaged; specifically in six located on the north face undergo an intense weathering and one of the elements is fractured by two vertical planes.

CEDEX asked INES to do a diagnostic study and different proposals of action. As a result of this works, it was concluded the need to replace the 6 most affected cymatium; as well as an active shoring system and a replacement procedure were sized.

The Ministry of Culture required INES then the Construction Management of the Emergency Project awarded to the company Betazul. Its aim is to replace the current shoring with a new more effective one, in order to allow applying vertical forces, which unload the cymatium before its replacement.

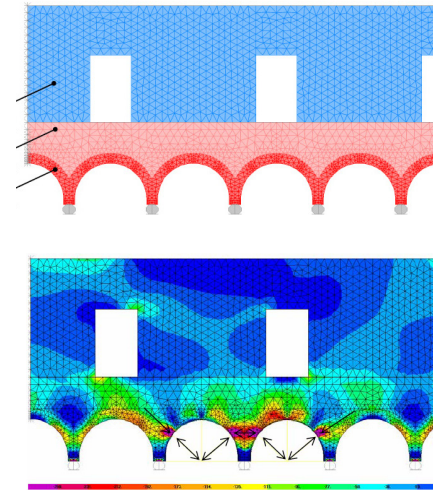
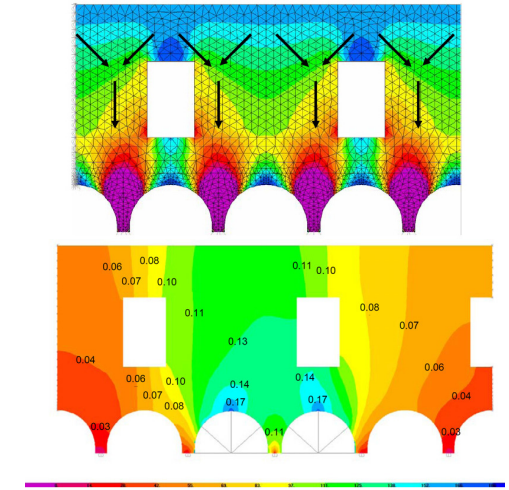
The vertical load resting on each cymatium is about 200 kN, which suppose compression stresses of 2.2 N / mm^2 and pulling stresses of 0.27 N / mm^2 in the stone. These values are very moderate compared to the characteristics of the intact stone, but high of compared to the characteristics of the ostonera when it is strongly weathered.
