## The Wall of the Western sector of the Alcazaba

### Mérida

CLIENT	<b>Culture Office. Government of Extremadura</b>
PROJECT DATE	<b>2007</b>
LOCATION	<b>Mérida, Spain</b>
FIELD OF ACTION	<b>Research &amp; Restoration projects</b>

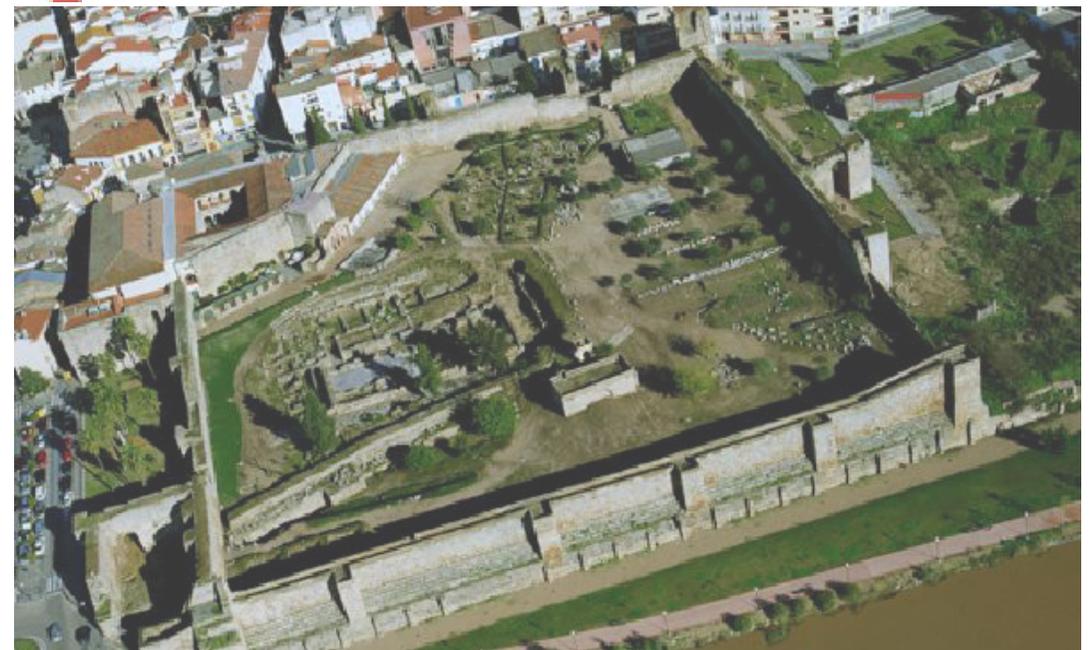
The main reason of the detected damage is the loss of the case-hardening stuffed inside the walls and the bad grain size measurement.

The stuffing is out of condition principally due to the suffered washing through the run-off water flowing from the crown to the base of the walls, where it comes out sweeping a part of the filling material.

It has been also detected strength damage (fissures, separation of ashlars, convexity of the walls, etc.) which mean an incorrect tensional operation, because of a poor durability or a wrong maintenance of the structure, rather than a bearing failure of the wall.
