Padre Huidobro Avenue Bridge, Highway A-6 Madrid

CLIENT	Madrid City Council
PROJECT DATE	2014
LOCATION	Madrid, Spain
FIELD OF ACTION	Construction project and Technical assistance during construction

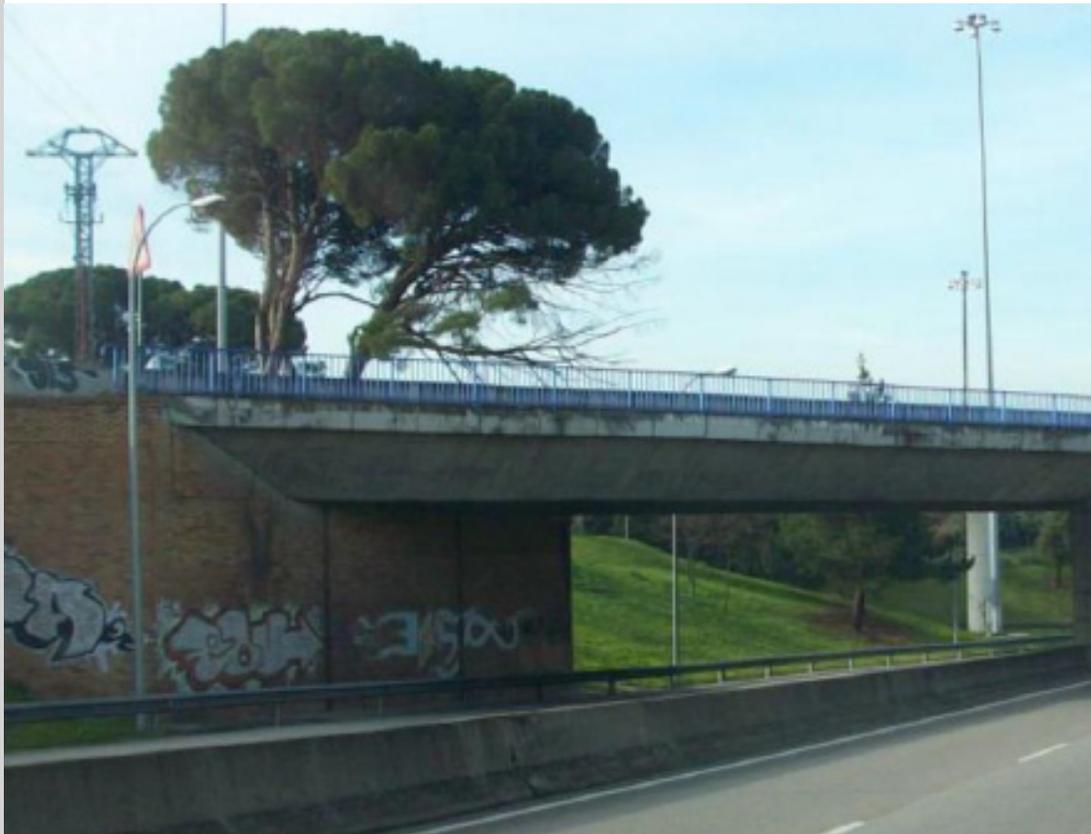
The main damages of the structure were the moisture, leaks and efflorescence on both spans of the slab due to an inappropriate waterproofing; patina because of the corrosion of the slab reinforcement; and cracks of medium importance. In the pier, there are cracks on the top of the shaft lining, due to an excessive pressure between elements. In the brick of the abutments and wing-walls, lining were found both cracked and loose elements due to the excessive pressure, as well as moisture and leaks because of the bad waterproofing. On the platform the pavement had general damages.

The upper layer of the pavement was removed, in order to place a new wearing course of hot bituminous mixture with 4 cm depth.

Firstly, the concrete walls were cleaned and sanitized waterjetting at high pressure. Then an anticarbonation treatment was spread, consisting of a special translucent satin paint, which also eliminates the concrete spots. Specific stains on masonry were cleaned by mechanical brushing and solvents application.

In order to repair the fissures or cracks and the vertical relative movements in relation with the concrete wall, first those cracks were injected with milk at low pressure.

The cracks of the lower face of the slab were sealed with an epoxy material, in order to carry out its structural regeneration. The deteriorated expansion-joints were restored with new ones of the same typology, but with a Hypalon band to collect the run-off water. Also a water dip element was done placing an angular galvanized steel profile, on both sides of the deck.
