Restoration of the arcade of Bojes Patios

Sevilla

CLIENT	CEDEX. Ministry of Culture
PROJECT DATE	2009/2010
LOCATION	San Fernando, Spain
FIELD OF ACTION	Research & Restoration projects

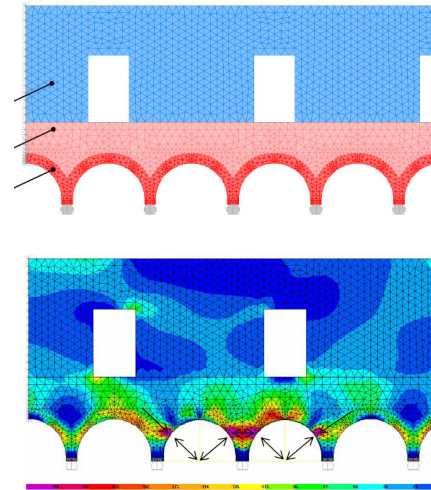
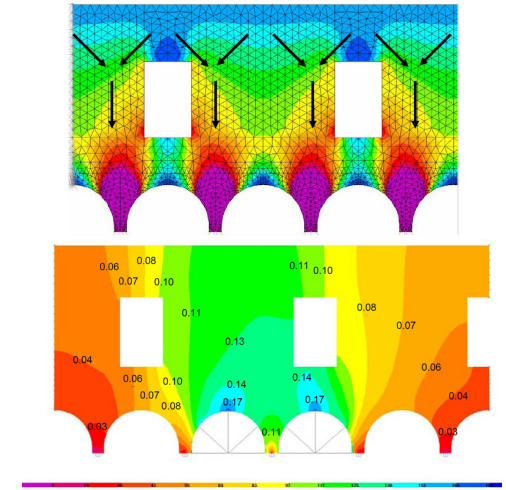
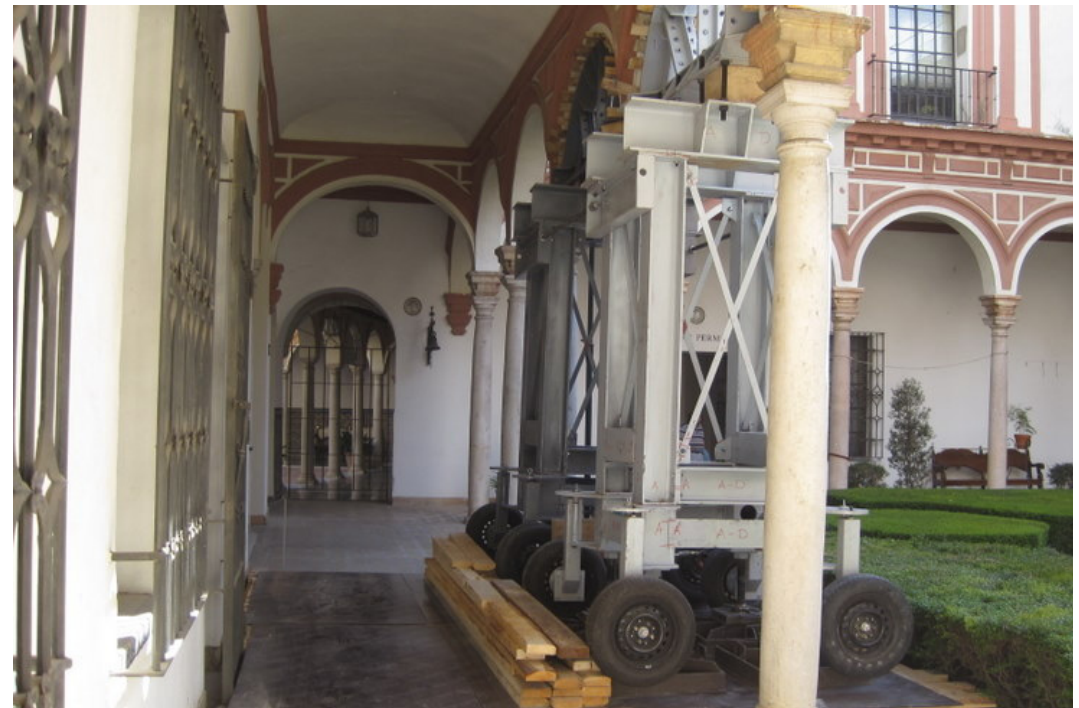
Many of these cymatium, are considerable damaged; specifically in six located on the north face undergo an intense weathering and one of the elements is fractured by two vertical planes.

The vertical load resting on each cymatium is about 200 kN, which suppose compression stresses of 2.2 N / mm^2 and pulling stresses of 0.27 N / mm^2 in the stone. These values are very moderate compared to the characteristics of the intact stone, but high of compared to the characteristics of the ostonera when it is strongly weathered.

CEDEX asked INES to do a diagnostic study and different proposals of action. As a result of this works, it was concluded the need to replace the 6 most affected cymatium; as well as an active shoring system and a replacement procedure were sized.

The Ministry of Culture required INES then the Construction Management of the Emergency Project awarded to the company Betazul. Its aim is to replace the current shoring with a new more effective one, in order to allow applying vertical forces, which unload the cymatium before its replacement.
