Restoration of La Rioja Museum

Logroño, La Rioja

| CLIENT | CEDEX-Ministry of Culture |
| PROJECT DATE | 2005 |

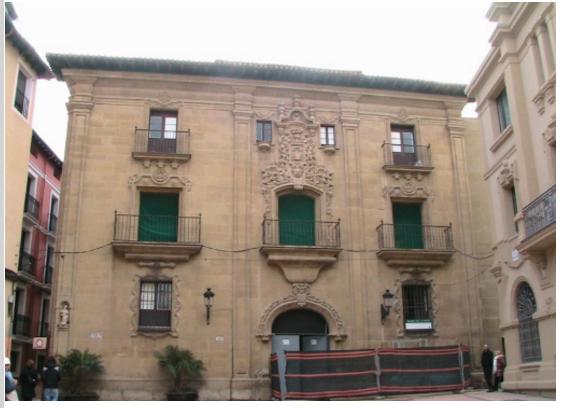
ines@inesingenieros.com www.ines.es/en The old Espartero Palace is a Baroque building from the eighteenth century. Nowadays is were La Rioja Museum is located. The building has almost a square floor, with about 20 m side. The building has three independent facades and another one dividing with the extension building. In elevation view, it has a ground floor, besides the three upper ones and the roof on the top. The overall height is 14.40 m. The ground plan is organized around the facade walls and the central stair, quasiparallel to the formers. The decks are made up of wood beams and rubble filling, resting on the walls by purlins and lintels. The foundation is unknown, although very superficial supports have been detected through the different samplings made up in some interior walls.

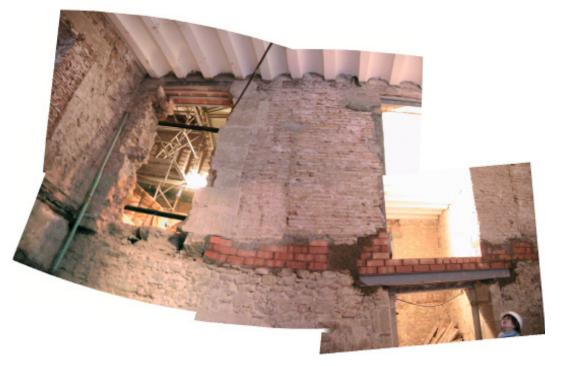
The building has undergone many changes in all its elements, due to the different owners, that it had simultaneously. As a result of that fact, the Palace has nowadays disorganized elements and often without structural coherence. During the development of the restoration works, as well as during the withdrawal of the plasters and ornaments, finally appeared structural elements and it could be studied their type and condition. INES Engineers hat worked together with the CEDEX in the following tasks: auscultation, structural analyzes and redesign of the construction project and also of the required reinforcements concerning the foundation, the wood decks and the bearing walls.
